# QuarterBack<sup>®</sup> Offset Test

## Summary

The SMP was originally designed to blind mate and tolerate misalignment. The QuarterBack<sup>®</sup> (QB) design features a bayonet locking nut on the standard SMP interface for a secure yet low withdrawal force RF and microwave connection.

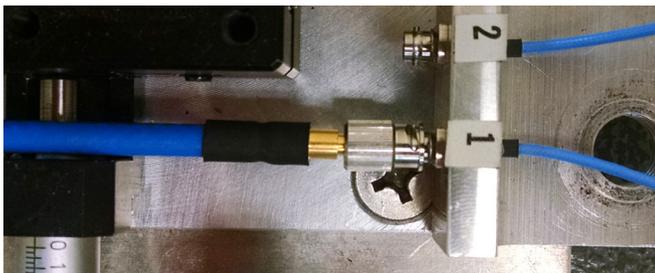
Figure 1: Nominal

The cables were plotted in the nominal position (Figure 1) and then biased perpendicular to the connector axis to their physical limit (Figure 2) in four different directions. Any further force applied would result in noticeable physical damage to the outer body of the connector itself and in real applications would result in destructive damage to the cable termination.

QB male panel mount connectors (SF1211-66204) were terminated to Ø.047 FlexTra<sup>®</sup> (200-70-214) and mated to QB female T-Flex 405 flexible cable assemblies. The opposing end of the test cables were terminated with 2.92mm male cable connectors.

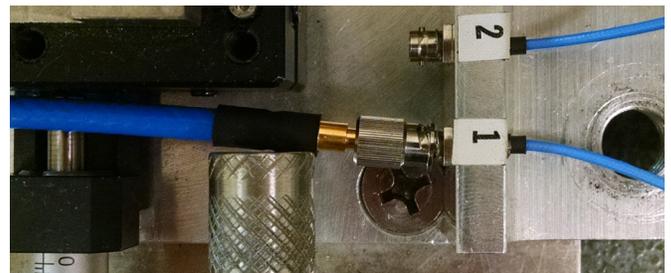
Figure 2: Offset position (offset “left” shown)

The designations shown in the chart legend are considered up, down, left, and right when looking into the QB male interface and considering the lab bench to be the bottom.

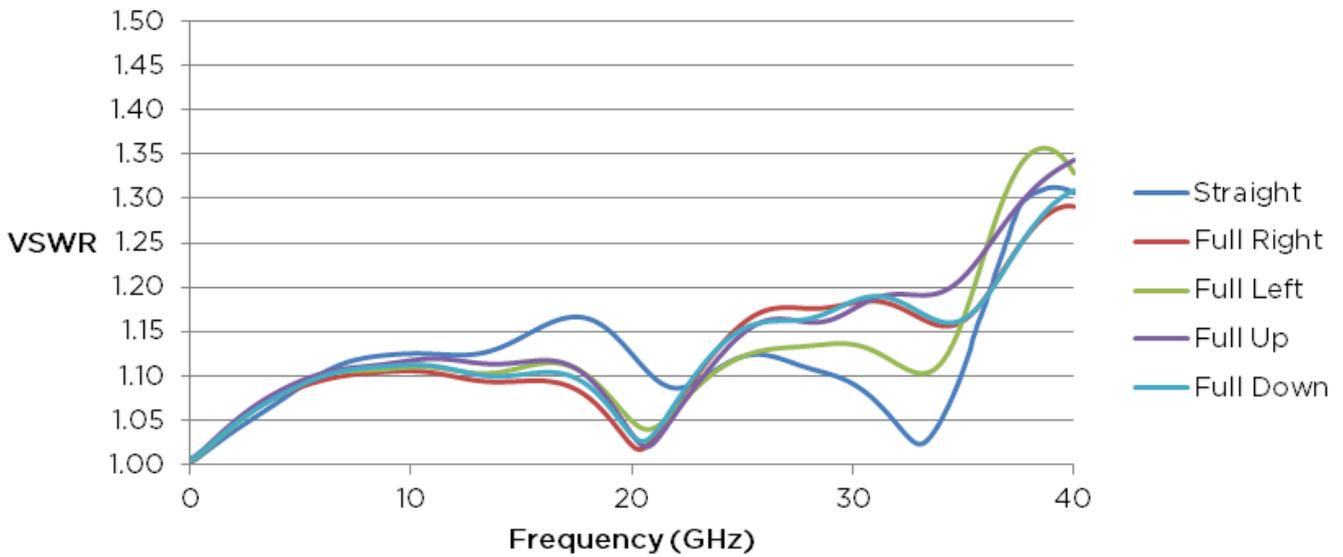
### Misalignment - VSWR

VSWR and Insertion Loss plots were collected from 10 Mhz to 40 GHz. VSWR results were gated and include the entire mated pair and cable transition, including approximately .125" of cable length. Insertion loss results are given for the entire test cable - from 2.92mm male, through the QB mated pair, and ending at the other 2.92mm male.

There was no significant negative performance impact observed in either VSWR or insertion loss. Plots below:
